**MARYLAND HISTORICAL TRUST  
DETERMINATION OF ELIGIBILITY FORM**

BA-2327

Tool House, Spring Grove

## State Historic Sites Inventory Form

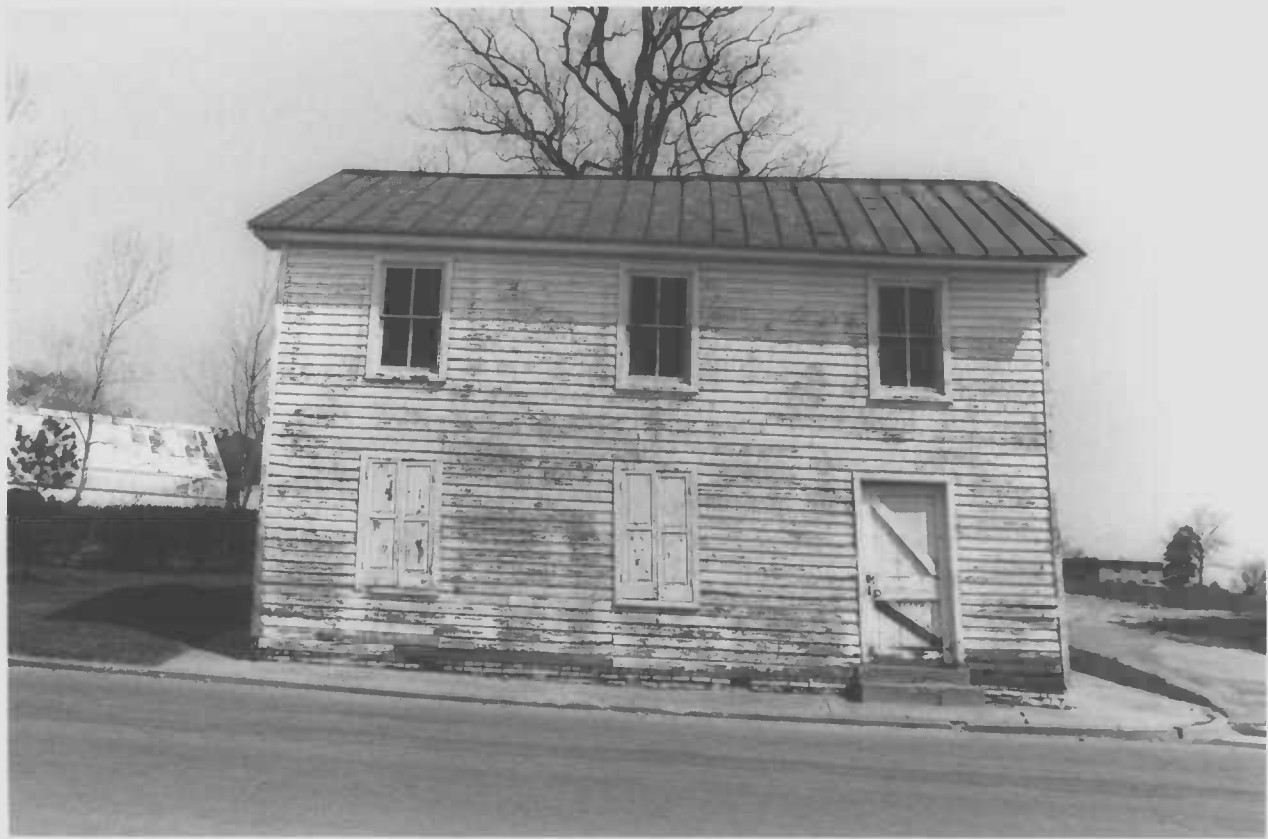
SOUTH WALL

The Tool House is a two story frame building, located southeast of the Laundry Building. The shiplap building rests on a brick foundation. Measuring three bays long and two bays deep, the Tool House is covered by a tin, gable roof.

The fenestration throughout the building is characterized by frame surrounds, sills and lintels. The first floor windows display wooden shutters but the window panes have been sealed with plywood. In contrast, the second floor windows lack shutters but show 2/2 double-hung sashes.

The current function of the building is, predominantly, to store wooden planks. The walls have remained unfinished since the building's construction in 1908. The stability of the structure is potentially threatened by its slanting stature.

The original colors of the Tool House were quite bright. The green shutters contrasted with the deep red of the frame siding. The building has experienced few if any alterations. Structural problems plague the brick foundation, resulting in a noticeable slant of the building. The plain interior remains unfinished and continues to function as a tool house and lumber storage.

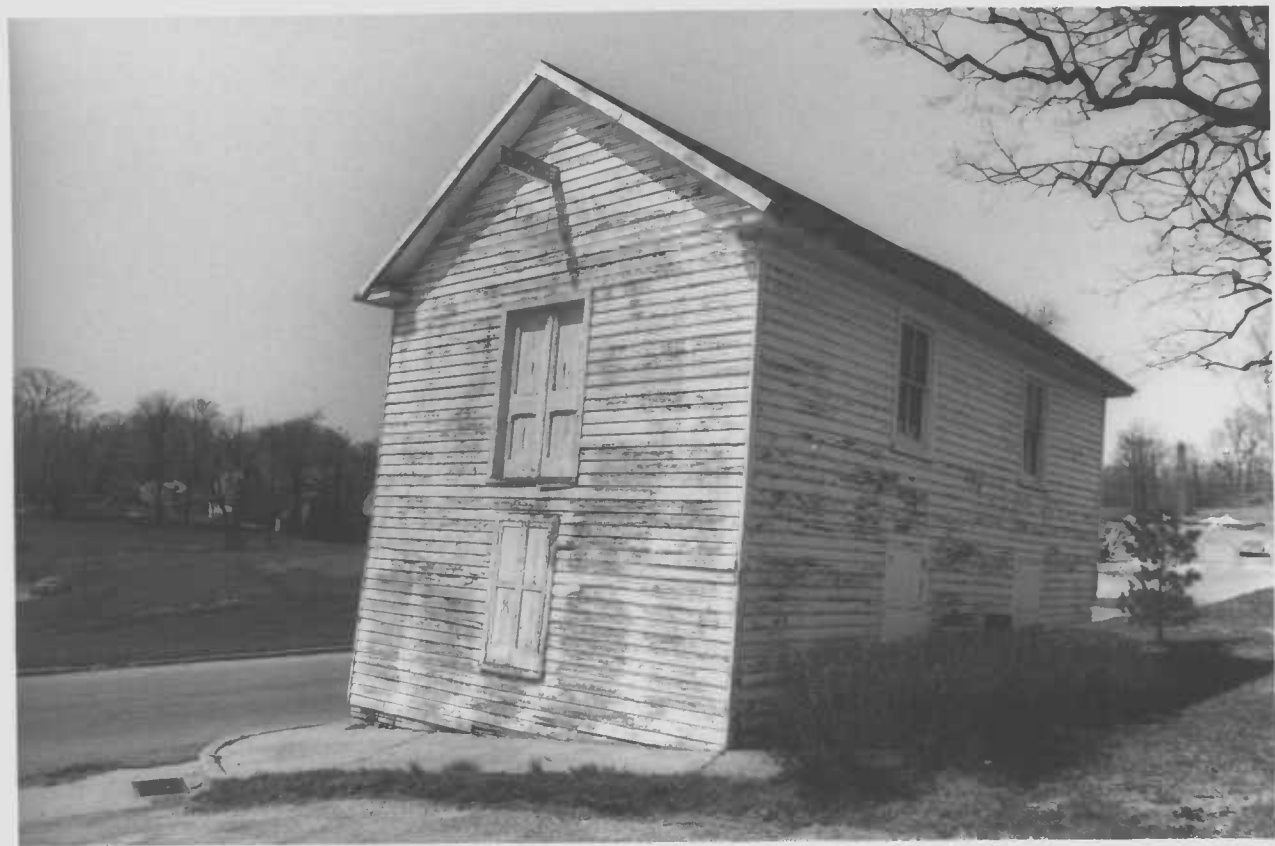
EAST AND NORTH WALL

The east and west faces exhibit simple gable ends with boxed returns and plain projecting verges. The west facade has a single, paneled door with a frame surround and a brick sill. The east face displays two centrally located openings. The first floor opening is a window with the standard treatment. The second floor opening is a double door, constructed of clapboard. Above the door, a pulley attached to a board projects away from the wall.
